Occupational Risk Assessment: Review of Wooden Scaffold Board Application in Malaysian Oil and Gas Industry

MOHD JAMIL ABDUL WAHAB*, NOOR AZRIEDA ABD RASHID,
SALMIAH UJANG & LIM SENG CHOON

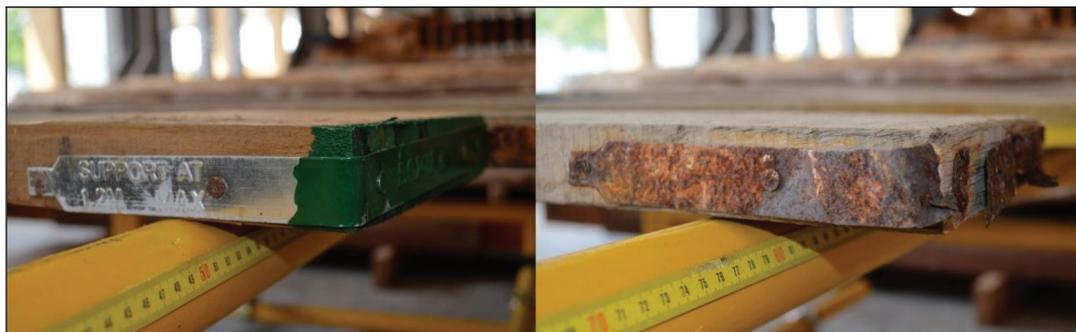
End bands of the scaffold boards were made of metal plates with a nominal dimension of 0.8 mm thick and 20.0 mm in width. These end bands were nailed on the sides and cross sections of the timber boards. Based on AS 1577, fixing of end bands made of metal, plastic or wood is compulsory to restrain end splitting. Figure 2 shows the effect of exposure to oceanic atmosphere on a metal end band. Metallic substances severely deteriorate in corrosive marine environment, particularly when the material was entirely submerged below the sea during high tide. It was observed that both the end bands and the nails were extensively corroded. Many parts of the end bands were destroyed and end bands of some boards were completely loss. The deterioration of the metal plates formed spiky and harmful edges. Act 139 of Malaysian Laws (Anon. 1986)

FIGURE 2. Illustration of an end band before and after exposure to oceanic atmosphere

stated that metal parts in scaffolding application shall be of suitable quality and free from corrosion. Besides, concern about the sharp edges on end bands is stated in BS 2482 as to avoid injury to workers. Thus far, this subject has never been an argument of safety, but it is definitely important for future improvement of timber scaffold board application.

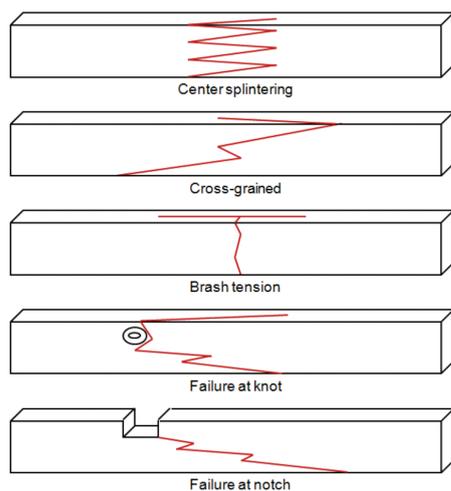
Overall, there were five modes of fracture observed during destructive test namely center splintering, cross-grained, brash tension, failure at knot and failure at notch. The facies of failure is described in Figure 3. Correlation between density, maximum load and failure mode of each board is shown in Figure 4. High density boards demonstrated higher maximum strength. Most boards of higher strength failed by center splintering. Apparently, majority of the lower strength boards failed in brash tension mode.

As fracture always begin at a defect point, timber boards which failed in splintering mode are most likely having straight grain and free of knot. Nevertheless, crossing grain and knots can be distinguished with a proper visual grading procedure. Brash tension failure is normally associated with decay, characterised by abrupt breakage across the grain without splinters (Highley & Scheffer 1989). Thus, species and grades selection plus periodical inspection on the timber boards are vital to prevent decay.

FIGURE 3. Facies of timber scaffold board failure (bottom view)

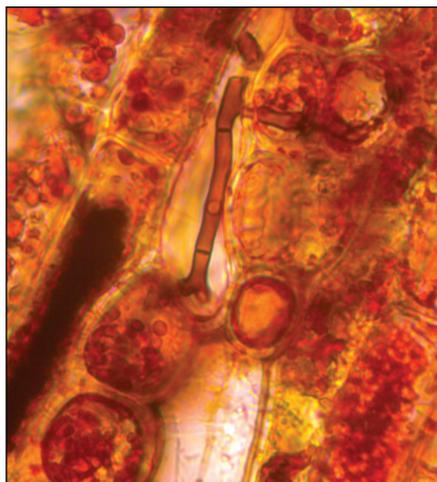
FIGURE 5. Microscopic view of hyphae on a sample slide

presence of hyphae (Figure 5). The growing phase of fungi is characterised by hyphae in the form of microscopic threads that developed from germinating spores. In addition, hyphae indicated the extent of microbiological deterioration of the timber boards.
