Seismic Performance of Earth Retaining Structures under Case Histories Earthquakes

Abbas Jawad Al-Taie^{a,b*} & Mahmood Diab Ahmed^b

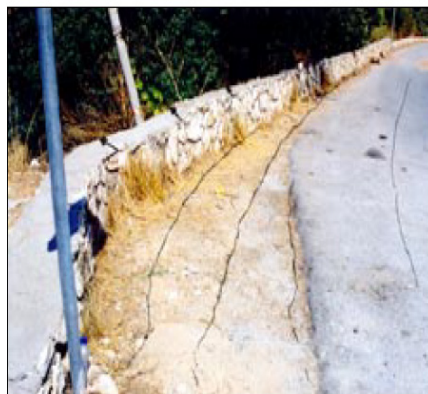
FIGURE 3. Leaning of RWs during Lefkada Island Earthquake (from Margaris et al. 2003)

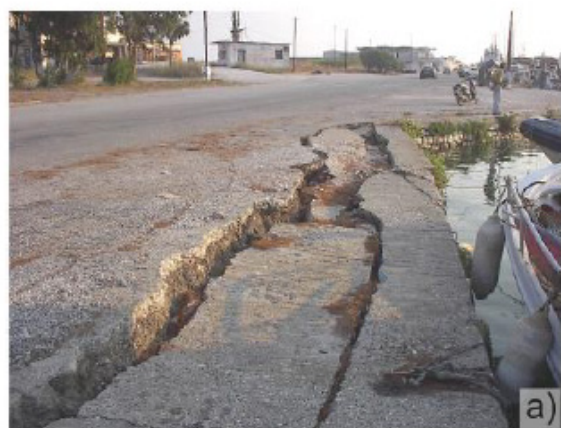
FIGURE 4. Displacement of quay RWs during Lefkada Island Earthquake (from Pitilakis & Roumelioti 2013)

Among the investigated cases, an interesting instance was noted for the case of (5m x 5m) concrete rigid gravity quay retaining walls in the Lefkada Marina. (Gazetas et al. 2005) examined the performance of these walls during the Lefkada Island Earthquake (2003). These walls were designed, following the Greek seismic-code (EAK, 2000), using a ground acceleration value of 0.36g as a basic value in the analysis and based on the “Newmark sliding block method.” Although the investigated systems have experienced damage, they performed well compared to other retaining systems designed according to conventional practice. In reality, the recorded damages were only small-scale. On the other hand, it was found that the Newmark method fails to calculate the considerable permanent displacement of quay walls resulting from the Lefkada earthquake. Furthermore, under the vertical acceleration

| | | (5m x 5m) rigid gravity (concrete) quay RWs | The recorded damages include rotation and lateral displacement of the quay RWs | |

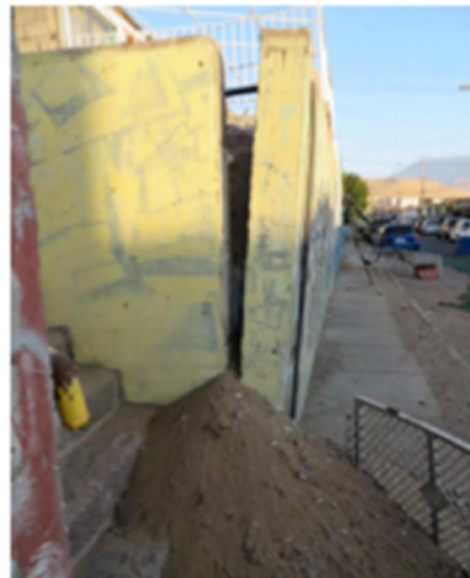
Rotation of the concrete cantilever wall (without footing) about its base was observed under the ground motion in the Iquique earthquake, 2014, as shown in Figure 5. The rotation of this wall might be due to either the lateral earth pressure or the inertia of the wall. In contrast, there is no distress problem seen for an adjacent wall with the same height (Rollins et al. 2014; Wagner & Sitar 2016b). Overall, the performance of ERSs after the Iquique earthquake, 2014, was considered satisfactory (Candia et al. 2017).

FIGURE 5. Rotation of concrete cantilever RW during the Iquique Earthquake (2014), (from Wagner & Sitar, 2016a)

| Iquique Earthquake, Chile, 2014 | Iquique, Chile's coast, Chile, on 1 April, 2014, M =8.2, and a depth of 25 km | Concrete cantilever RW | Rotation of concrete cantilever RW about its base was observed under the ground motion in the Iquique earthquake, 2014 | (Wagner & Sitar 2016b) |

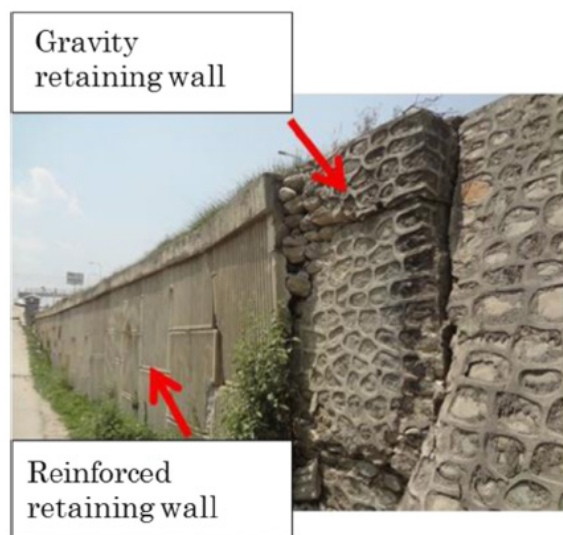
were observed with the damaged infrastructure; these are reinforced RW and gravity RW, as shown in Figure 6. According to Okamura et al. 2015, damages were observed in the joints between the RWs. The damages in the gravity RWs are represented by cracking in some parts of these ERSs. Overall, minimal damages and no failures were reported to ERSs during this earthquake (Hashash et al. 2015; Khan et al. 2024).

FIGURE 6. Damages of RWs during Nepal earthquake (from Okamura et al. 2015)

| Nepal Earthquake, Gorkha, Nepal, 2015 | Gorkha, Nepal, M=7.8 and depth 8.2 km | Reinforced RW and gravity RW | The joints between the RWs were damaged. Cracks were observed in the gravity RW | (Okamura et al. 2015) |

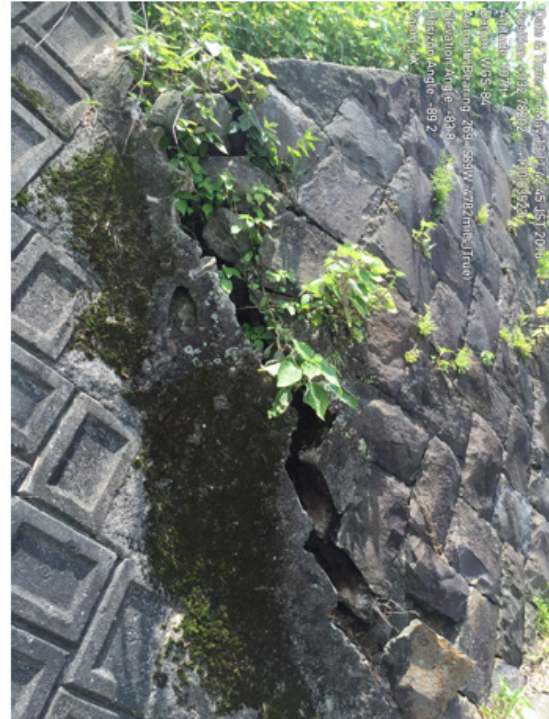
RWs with different lengths and heights). The damages reported for unreinforced concrete block RWs are lateral offsets of these walls; see Figure 7.

FIGURE 7. Lateral offset for unreinforced-concrete block RWs during Kumamoto Earthquake (from Kayen et al. 2016)

The values of the recorded offset varied depending on the height of the RWs. A 20cm offset was recorded for taller RWs, while a higher value (40cm) was for the shorter. While the unreinforced masonry RWs showed diagonal cracks, these walls fractured as shown in Figure 8. Furthermore, the unreinforced stone masonry RWs were damaged.

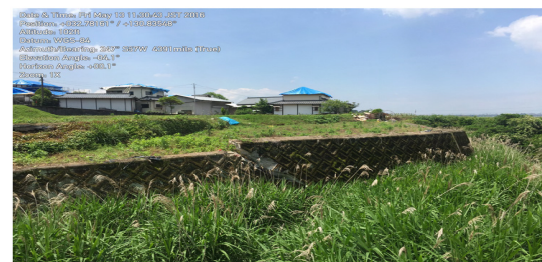
FIGURE 8. Diagonal cracks for unreinforced masonry RWs during Kumamoto Earthquake (from Kayen et al. 2016)

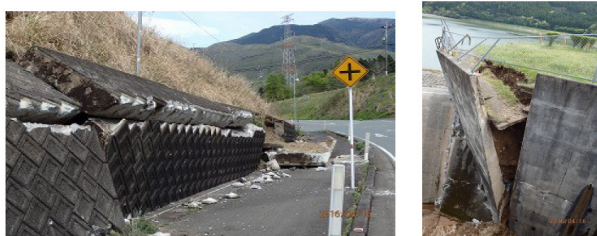
Caldera. The recorded and observed geotechnical damages in this surveying were soil liquefaction in different locations, significant deformation and settlement in some river levees and buildings, embankment damages, slope failures, and large-scale landslides (Mukunoki et al. 2016; Kiyota et al. 2017). Regarding the ERSs, three types of RWs were observed with the damaged infrastructure; these are cantilever RW, gravity RW, and reinforced soil walls, as shown in Figures 9 and 10. As can be noted, the cantilever and gravity walls were structurally damaged. In addition to the structural failure, the cantilever-type RW was excessively tilted. On the other hand, significant damage can be seen for reinforced soil walls, Figure 10. This damage was represented by the pulling out of the reinforcement strips from their position in the backfill soil side. The reason for this failure type was not identified, as stated by Kiyota et al. 2017.

FIGURE 9. Damages of RWs during Kumamoto Earthquake (from Kiyota et al. 2017)

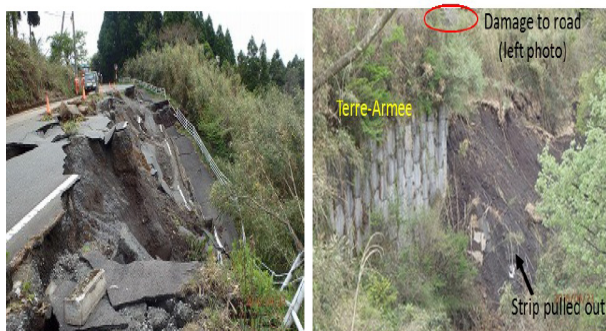
FIGURE 10. Damages of reinforced soil walls during Kumamoto Earthquake (from Kiyota et al. 2017)
