Corrosion Risk Assessment of Existing and New Reinforced Concrete Buildings after Six Years Tsunami Aceh 2004

M. Ridha^{a,c}, Syarizal Fonna^{a,b}, Syifaul Huzni^a, Israr^a, Zulfan Fauzi^a and A. K. Ariffin^b

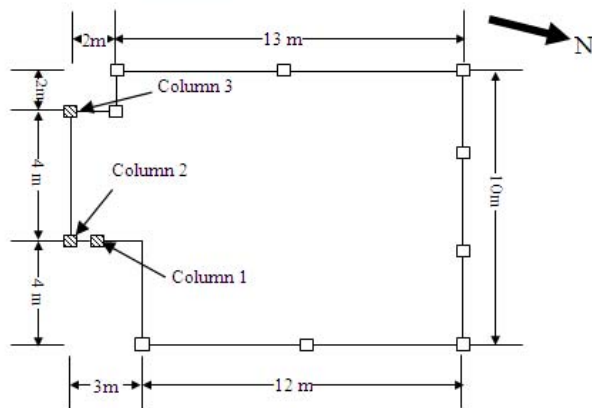
Fig. 5. The existing building in Kampung Jawa

The assessment of corrosion for tsunami affected buildings was started for civilian reinforced concrete buildings at Kampung Jawa. The existing building is shown in Fig. 5 and three columns were selected for the

assessment. This building located around 1.5 km from coastal line and submerged by seawater around 6 m high.

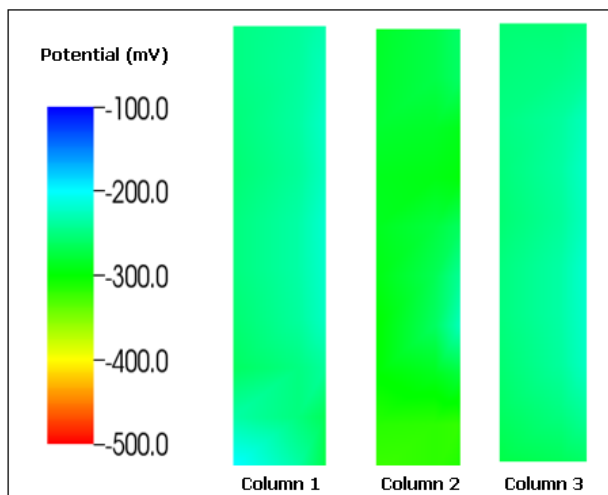
Fig. 6. Potential corrosion distribution for the existing building in Kampung Jawa

The potential corrosion distribution for the existing building in Kampung Jawa is shown in Fig. 6. The figure shows that the potential corrosion distributions were varying between -200 mV to -350 mV. It indicates that the corrosion risk level is already at intermediate.

From these data, it can be decided that the corrosion of reinforcement steels might took place there for all columns. It needs to take preventive action before the corrosion worsening and early failure occurs.

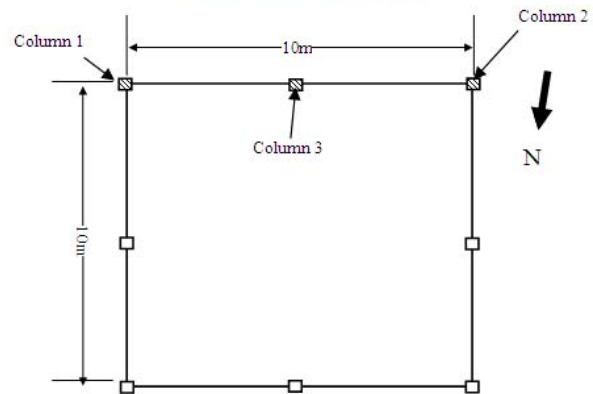
Fig. 7. The new building in Kampung Jawa

Fig. 7 shows the new reinforced concrete building in Kampung Jawa that built after tsunami 2004. This building also located around 1.5 km from coastal line.

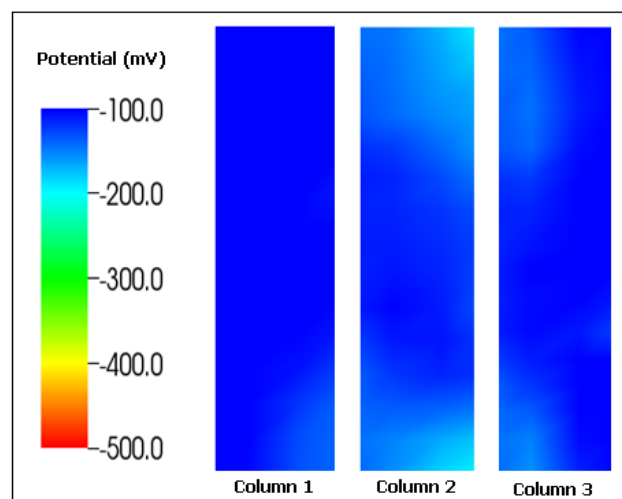
Fig. 8. Potential corrosion distribution for the new building in Kampung Jawa

The potential corrosion data that measured on the three columns surface of the new building in Kampung Jawa are

shown in Fig. 8. The potential values on the surface of concrete are ranged between -100 mV to -200 mV. It means that the corrosion level is low, only 10% corrosion risk.

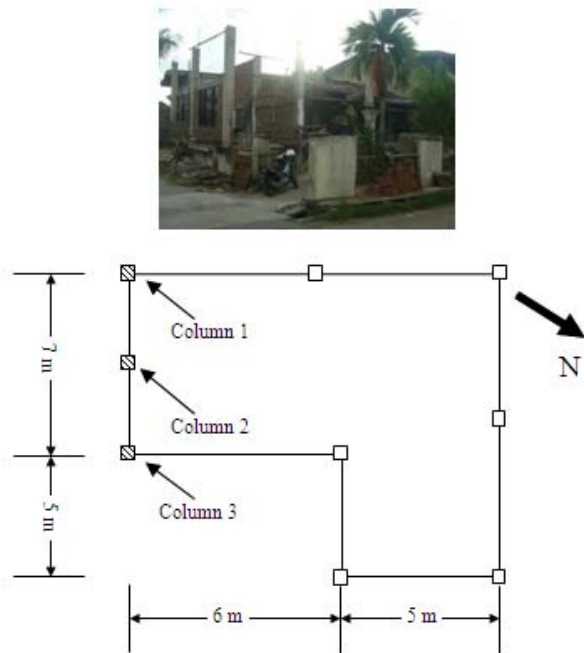
Fig.9. The existing building in Kampung Kramat

The corrosion assessment continued for the buildings in Kampung Kramat (Fig. 3). One of existing civilian buildings was chosen and three columns were selected. Fig. 9 shows the existing civilian building in Kampung Kramat. This building is located around 3.6 km from coastal line and during tsunami 2004 was submerged around 3 m high by seawater.

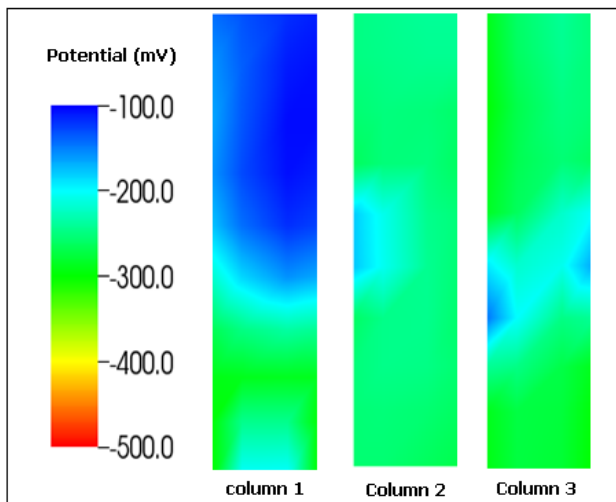
Fig. 10. Potential corrosion distribution for the existing building in Kampung Kramat

Fig. 10 show the potential corrosion distribution for each column of existing civilian building in Kampung Kramat. Majorly, all column are already at intermediate corrosion risk level (-200 mV to -350 mV), although, some part at column 1 is still at low corrosion risk. Hence, the corrosion might already occur at all columns.

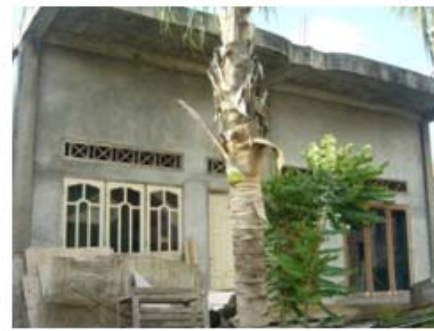
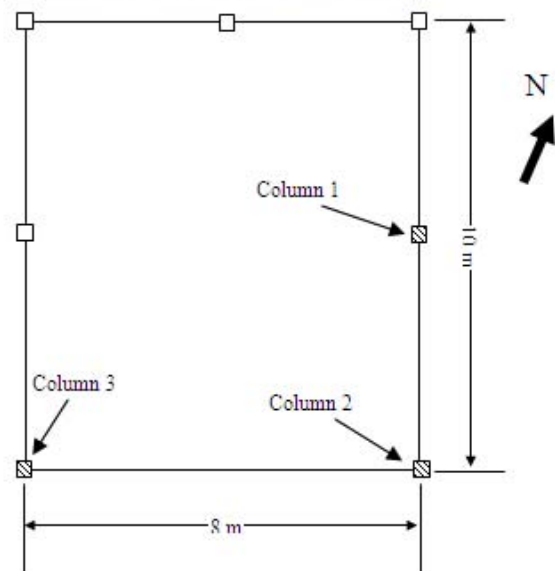
Fig. 11. The new building in Kampung Kramat

The new building in Kampung Kramat that becomes the object of the assessment is shown in Fig. 11 and also located around 3.6 km from coastal line.

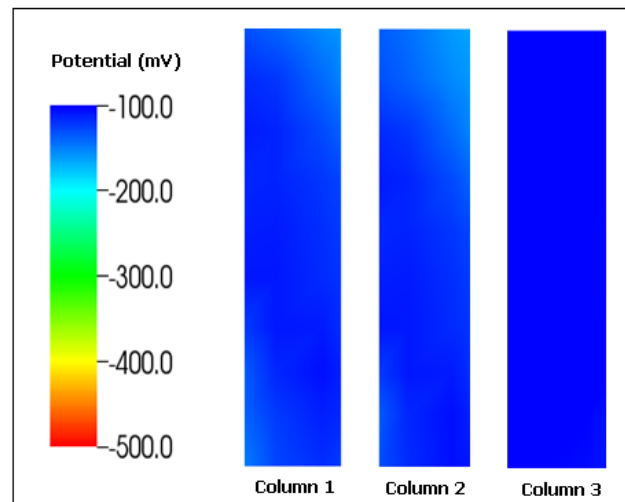
Fig. 12. Potential corrosion distribution for the new building in Kampung Kramat

The potential corrosion measured on the three columns surface of the new building in Kampung Kramat are shown in Fig. 12. The potential values are ranged between -100 mV to -200 mV and means that the corrosion level is low, only 10% corrosion risk. It can be decided that there was no corrosion occur in these column.

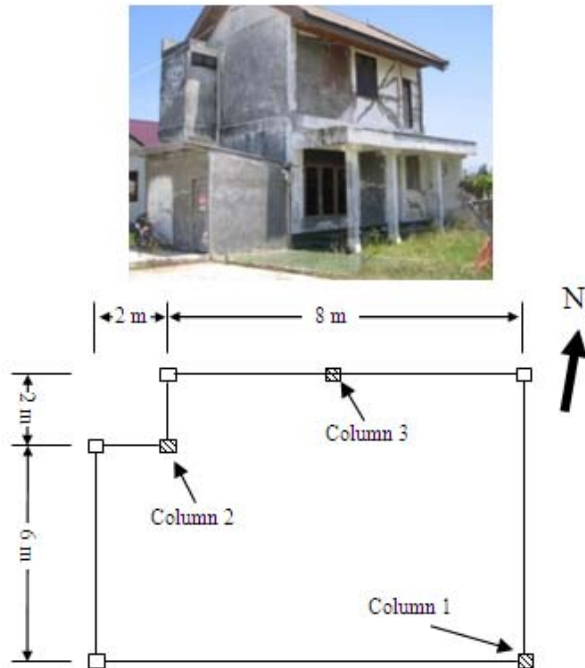
Fig. 13. The existing building in Lamjabat

The assessment continued for the existing building in Lamjabat that also struck by tsunami Aceh 2004. Same as before, three columns were selected. Fig. 13 shows the existing building in Lamjabat. The building is located around 1.5 km from the sea and submerged by sweater around 7 m during tsunami 2004.

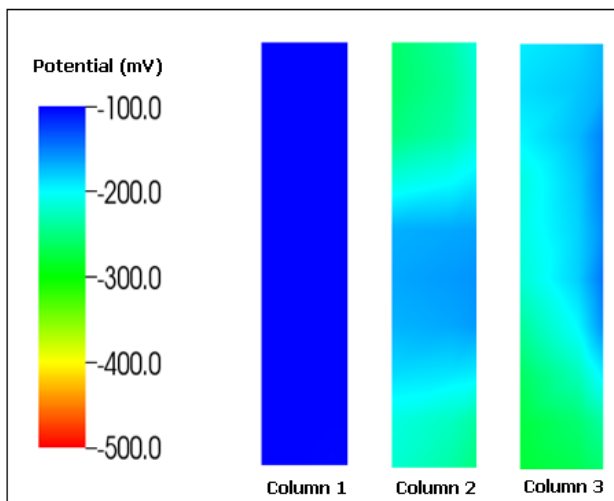
Fig. 14. Potential corrosion distribution for the existing building in Lamjabat

The potential corrosion distribution for each column of existing building in Lamjabat is shown in Fig. 14. The

corrosion risk level for column 2 and 3 was intermediate corrosion risk that indicated by the potential corrosion ranged between -200 to -350 mV. It was almost the same as previous results. The corrosion might already occur in those columns. Thus, it needs to take preventive action before the corrosion worsening and early failure occurs.

However, the corrosion level for column 1 was low risk (10% corrosion risk). It might due to the recasting of the column after tsunami 2004. Hence, there is no corrosion or the corrosion already stop.

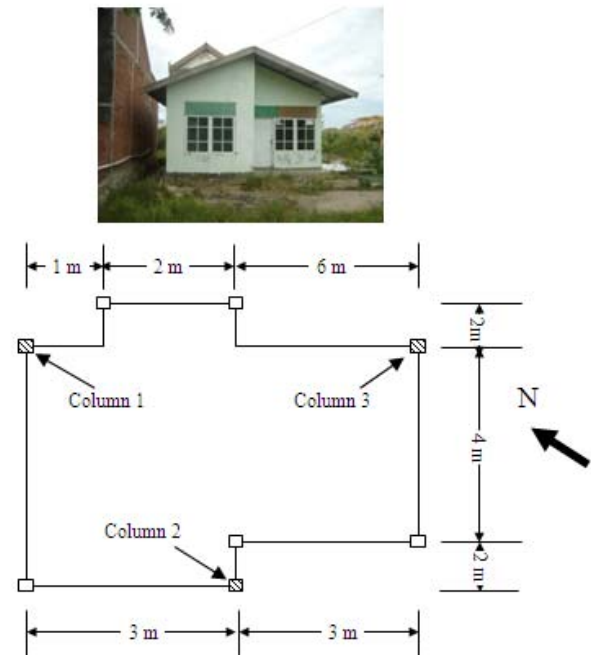
Fig. 15. The new building in Lamjabat

The new building in Lamjabat is shown in Fig. 15 and also located around 1.5 km from the sea. Three columns were selected for the assessment as seen in the figure.

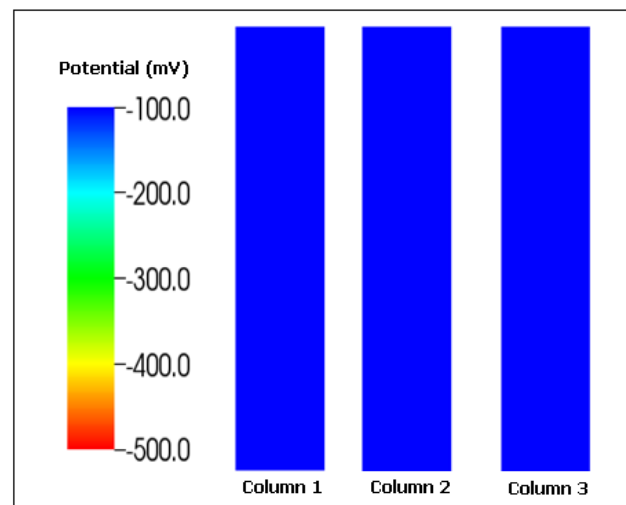
Fig. 16. Potential corrosion distribution for the new building in Lamjabat

The potential corrosion of the new building in Lamjabat is shown in Fig. 16. The potential values on the concrete surface are higher than -200 mV and means that the

corrosion level is low, only 10% corrosion risk. Hence, the building might be categorized as safe from the corrosion attack.
