Internal Characteristics of Loose Solid Source of Debris Flow in Zhouqu (Ciri Dalaman Sumber Pepejal Bebas Aliran Puing di Zhouqu)

ABSTRACT

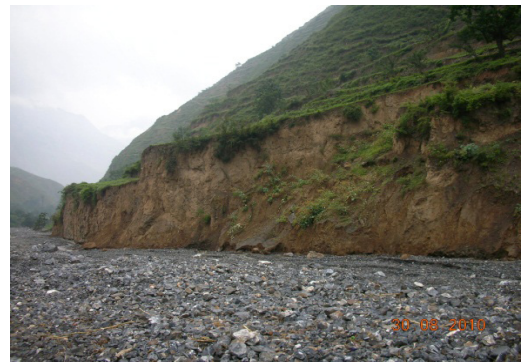
PHOTO 1. A collapse at the study area

According to field investigation, the loose solid source of debris flow in the research area mainly included collapsed accumulation, landslide accumulation, residual slope accumulation and valley accumulation and the collapsed accumulation was the main loose solid source of debris flow in this basin. In addition to debris flow formed by direct accumulating or blocking of valley by collapsed mass and landslide mass, the debris flow on slope formed by the erosion of loose collapse mass and landslide mass on the slope by slope runoff was also one of the main factors causing the debris flow in valley. Therefore, landslide accumulation and collapsed accumulation were sampled as the test objects (Photos 1-2, Figures 1-2). Distribution of debris flow in Nanyu Valley and sampling points are shown in Figures 3.

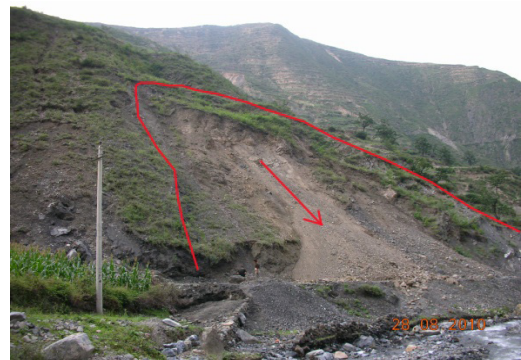
PHOTO 2. A slide at the study area

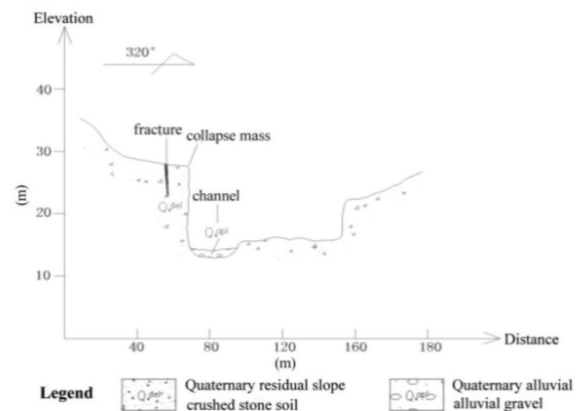
FIGURE 1. Sections of typical collapse

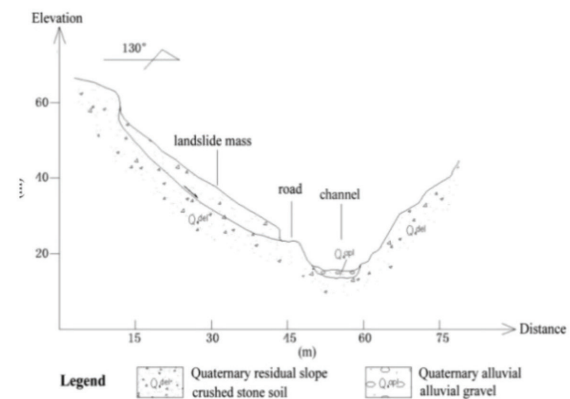
FIGURE 2. Sections of typical landslide

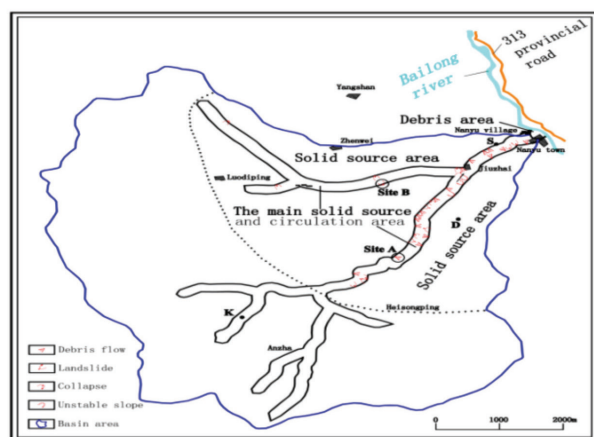
FIGURE 3. Distribution of debris flow in Nanyu Valley and sampling points

Water sampling A group of water at the slope toe, flowing water, spring water in the valley were collected and numbered as S1, K1 and D1, respectively;

Soil sampling A group of representative landslide accumulation and collapsed accumulation at the slope top and at the slope toe in the valley were collected respectively, and numbered A1, A2 and B1, B2, respectively;

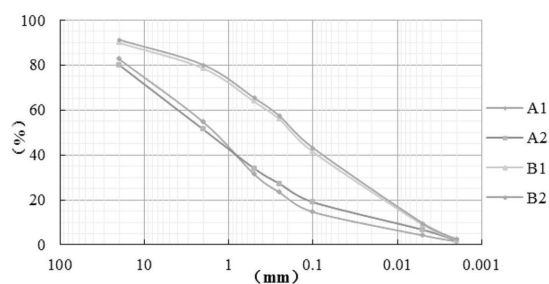
FIGURE 4. Particle size distribution curve of original sample

From particle size distribution curve shown in Figure 4, the high content of gravel and sand and the low contents of clay and silt in landslide/collapsed accumulation bodies provided a good condition for the infiltration of rainfall. The clays and silts accounted for 14.6% and 19% at the slope top (A1) and slope toe (A2) of the landslide accumulation body, respectively, which showed that many clays and silts at the slope top of the landslide accumulation body were scoured away by the runoff under the scouring effect of rainfall, thereby proving that the degree of soil erosion at the slope top was serious when the slope of the accumulation body was steep, exhibiting the characteristics of runoff gully development and considerably different particle sizes. The clays and silts accounted for 41.3% and 43.1% at the slope top (B1) and slope toe (B2) of the collapsed accumulation body, respectively, which showed that few clays and silts at the slope top of the collapsed accumulation body were scoured away by the runoff under the scouring effect of rainfall, thereby proving that: the degree of soil erosion at the slope top was not serious when the slope of the accumulation body was gentle.

The analysis results of particles at the slope top and slope toe of the landslide/collapsed accumulation bodies showed that: the loss of clays and silts was serious when the degree of soil erosion at the slope top was serious, exhibiting the characteristics of high dispersibility; the slope toe accumulated part of clays and silts scoured down from the slope top. Therefore, the contents of clay and silt gradually increased from the slope top to the slope toe.
