Posture Evaluation of the Automotive Maintenance Workers: A Case Study

Shukriah Abdullah^{a*}, Nor Kamaliana Khamis^a, Jaharah A. Ghani^a & Rudi Kurniawan^b

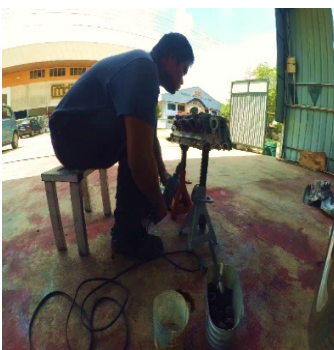
TABLE 3. Activity 1

Trunk	Bend over
	Arm	Two arm under the shoulder In extension 20-45° Wrist ≤15°
	Legs	Sit on chair Adjust >60°
	Load force	Hand tools weight <5kg

Table 3 to Table 12 show the picture and the detailed information of each selected activities in this study. This information will help to provide the score value for each factor that need to be evaluated as listed in REBA worksheet. As shown in Table 3, the worker needs to clean the engine valve. This posture occurs as the engine valve is placed on a table and the worker uses a self-made chair to find a comfortable working position during cleaning. Throughout the process, the worker's hand was positioned awkwardly, and his trunk can be seen bending towards the engine valve whilst he was seated. This posture was maintained for more than 10 minutes, before the worker lifted his trunk into a natural sitting position to relieve the discomfort on his waist. The worker continued the same movement for range one hour to three hour. The task involved entails high focus and accuracy as the ring valve needs to be cleaned for each valve.

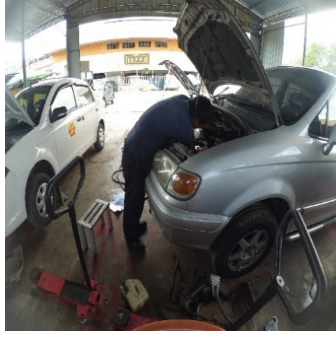
TABLE 4. Activity 2

Trunk	Bend over
	Arm	Under shoulder 45-90°
	Legs	Stand resting both feet
	Load force	Hand tools <5kg

As seen in Table 4, the worker needs to inspect and repair the car engine. This posture occurs amongst workers when they search for a problem in a car engine. The search takes a while, during which overreaching and excessive bending occurs several times (more than five times). After identifying the problem, repair activities start. Several movements take place in a single activity, for example, tightening and loosening bolts and nuts.

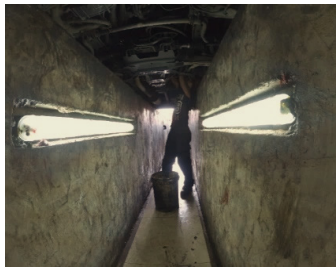
TABLE 5. Activity 3

Trunk	Lean on In extension 0-20°
	Arm	Two arm above shoulder
	Legs	Stand, while adjust
	Load force	<5kg

In Table 5, the worker is required to clean and replace the oil. In doing this task, the posture of the neck is positioned upward most of the time until the task is finished. Multiple hand and leg movements are made whilst trying to maintain the working position. Moreover, workers place their back on the wall to support their whole body whilst working. Minor activities such as tightening and loosening screws and cleaning are also part of the task.

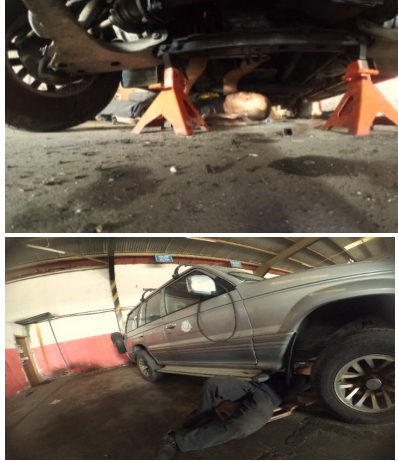
TABLE 6. Activity 4

Trunk	Lay over while in extension 0-20°
	Arm	Two arm under shoulder
	Legs	One feet resting on floor Adjust >60°
Load force	<5kg

Based on Table 6, the working posture occurs as the worker attempts to fix the fan wire in a specific space under the car. In such a task, the worker lies flat on the ground. Although this activity involves several movements, the hands are mostly used to work in a confined space. Owing to the discomfort caused by working in a confined space, injuries are prone to occur. This type of activity constantly places workers in direct contact with blunt objects, leading to bruises.

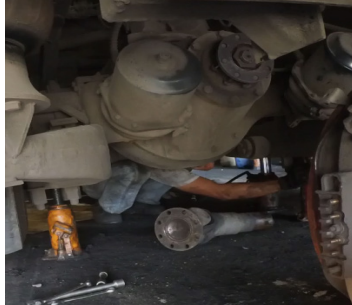
TABLE 7. Activity 5

Trunk	Bend over +60°
	Arm	Two arm under shoulder 45-90°
	Legs	sit
	Load force	<5kg

Referring to Table 7, the working posture occurs whilst lowering the gear box of the vehicle. Handling a gear box is one of the major tasks in maintenance activity. The gear box is a key part of the vehicle and requires considerable work due to the level of detail and safety needed whilst lowering it. This activity is simply part of the entire process of replacing the gear box. Whilst working in confined spaces, workers need to squat for a long time.

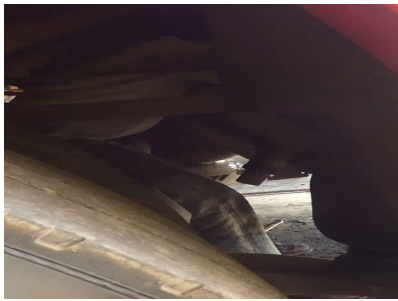
TABLE 8. Activity 6

Trunk	Bend over 20-60°
	Arm	Two arm under shoulder 45-90°
	Legs	Both feet resting Adjust 30-60°
	Load force	<5kg

As shown in Table 8, the working posture occurs when handling the chain. The task begins by pulling the 13 kg chain, handling it manually in a confined space under the vehicle and tightening it into the gearbox. During the activity, the worker's entire body was slightly bent as the worker sat on one of the vehicle shafts.

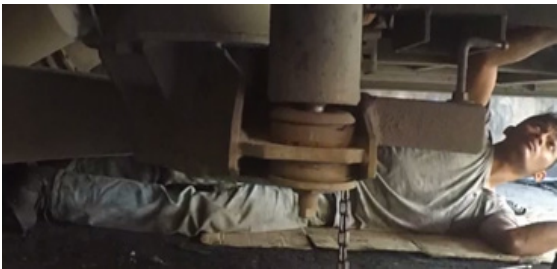
TABLE 9. Activity 7

Trunk	Lateral position Extension 0-20°
	Arm	Two arm under and above shoulder
	Legs	Adjust 30-60°
	Load force	<5kg

As illustrated in Table 9, this working posture occurs when one side of the body is held in parallel whilst identifying and checking a problem. The neck slightly looks upward whilst maintaining the position. Not much movement is involved on the leg whilst working in a confined area

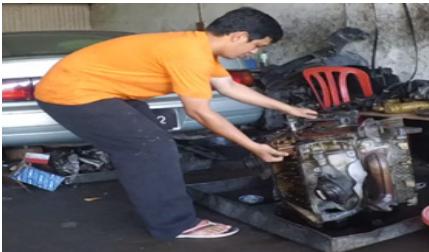
TABLE 10. Activity 8

Trunk	Bending >60
	Arm	Two arm under shoulder
	Legs	Two feet standing Adjust 30-60°
	Load force	Weight =136kg

In Table 10, manual handling is carried out whilst cleaning the 136 kg engine. The worker performed several movements in this task, such as side bending, squatting, pulling and slightly lifting the engine.

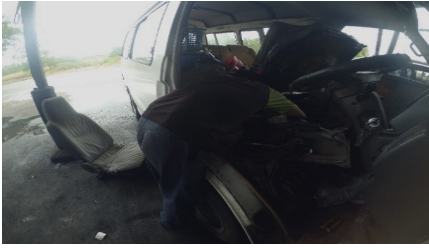
TABLE 11. Activity 9

Trunk	Bend over >60°
	Arm	Two arm under shoulder 45-90°
	Legs	Two feet stand rest
	Load force	<5kg

The task as shown in Table 11 was carried out on a van. Over bending is becoming a major problem whilst replacing components in the engine. The hand is overextended into the confined space of the engine to perform the task. Sometimes, the worker squats near the rim of a car seat opening to clearly see the component.

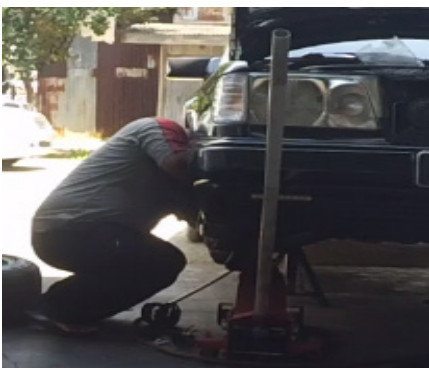
TABLE 12. Activity 10

Trunk	Bend over 20-60°
	Arm	Two arm under shoulder 45-90°
	Legs	Sit, adjust >60°
	Load force	>5kg

Activity 10 involves the vehicle absorber replacement. The weight of the whole body is placed towards the centre of the leg. Thus, the worker maintains an uncomfortable squatting position whilst pulling out the absorber. Whilst performing the task, the worker briefly rests by sitting on the vehicle tire and corrects the uncomfortable squatting posture. Several hand movements are needed to pull out the absorber and to tighten and loosen the screw. The head of the worker goes inside the tire area to take a clear look on the repair needed.
