## Review on Fire Incidents and Coating Methods for Fire Prevention in Timber Structures

S. M. Priok Rashid, Shahrizan Baharom\* & A. B. M. A. Kaish

*Department of Civil Engineering, Faculty of Engineering and Built Environment,  
 Universiti Kebangsaan Malaysia (UKM), Bangi 43600, Selangor, Malaysia.*

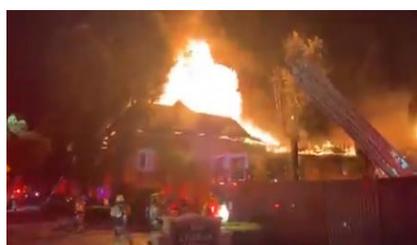
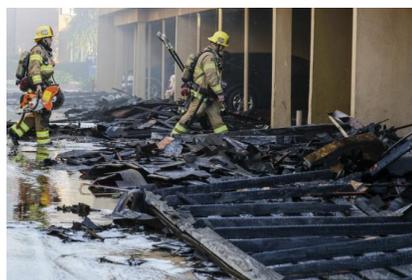
FIGURE 1. An apartment fire in Tustin, USA. (Gernay & Ni 2020)

A massive fire made a great impact on a complex apartment in Tustin, California, USA (Gernay & Ni 2020). The building was a two-story timber-framed building. Based on the North American classification system, the incident was categorized as a five-alarm fire. Arson was the reason for the fire. It began on the first floor and rapidly extended to the upstairs of the complex. A courtyard was in the center of the complex. Figure 1a depicts how the building was completely destroyed by the fire as it spread throughout

the structure. Within 24 minutes, the complex's roof collapsed, injuring two people. Figure 1b shows firefighters extinguishing hotspots and searching for occupants over five hours after the 911 call. Around 120 firefighters responded. 38 of 40 units destroyed and approximately 100 residents displaced.

(a) Fire spreading the building

(b) Firefighters working

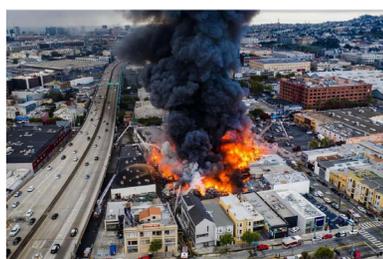
FIGURE 2. Several buildings affected by large fire (Keeley & Syphard 2021).

A significant fire was experienced in San Francisco, USA (Figure 2) (Keeley & Syphard 2021). Five nearby buildings within a two-block area were rapidly affected by the fire when it started early in the morning. It took 160 firefighters using 60 vehicles to stop the fire, which was burning intensely and spreading rapidly. In a short time, the firefighters were able to put out the fire. Six buildings were completely destroyed. To check for hot areas, firefighters stayed overnight on the incident. One firefighter was reported as having a minor injury.

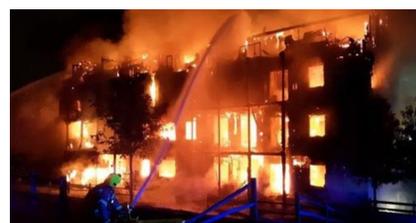
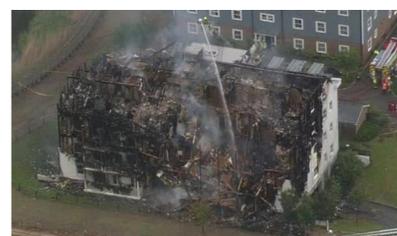
FIGURE 3. Fire in an apartment in Worcester Park, UK. (Taylor & Appleby, 2020)

A fire broke out at Worcester Park in London, UK (Taylor & Appleby 2020). The four-story timber frame structure had 20 apartments. Noncombustible cladding and light-frame construction made up the construction system.

No sprinkler was present in place. From a timber balcony, fire was initiated. After entering the cavities of the timber structures, it rapidly spread across the whole structure, as illustrated in Figure 3a. The firefighting operation required around 125 firefighters, 20 pumps, 20 fire engines, and aerial platforms. Five hours was the duration of the fire. As illustrated in Figure 3b, the structure was fully demolished in the end. The fire did not spread to adjoining buildings.

(a) Fire in the building

(b) The building after the fire

A total of 150 persons had to evacuate during the event. The lack of warning equipment in several units resulted in numerous tenants being clueless to the fire until neighbors notified them by pounding on their doors. Fortunately, there were no recorded injuries or fatalities. The tragedy prompted UK authorities to reconsider requiring sprinklers in residential buildings under 18 meters. Furthermore, it highlights the importance of installing warning systems within individual units.

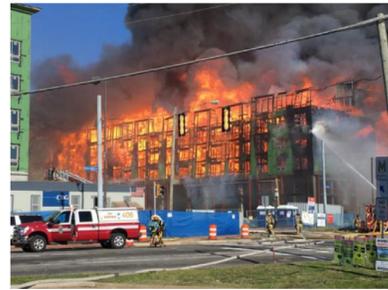
FIGURE 4. A huge fire in multi-story construction site and firefighters battling (Elsanadedy et al. 2022)

As shown in Figure 4, fire destroyed a five-story building in Washington, D.C., USA (Elsanadedy et al. 2022). The incident was considered to be a four-alarm fire. The fire began at the top level of the building. As the

building was under construction, no sprinkler system was installed. The weather was quite windy, which made it challenging to put out the fire. The fire completely destroyed 14 residential units and damaged 28 vehicles. 150 firefighters worked in this incident. Firefighters controlled the blaze for eight hours. A nearby community's residents were evacuated. With minor injuries, one tenant and two firefighters were sent to hospitals.

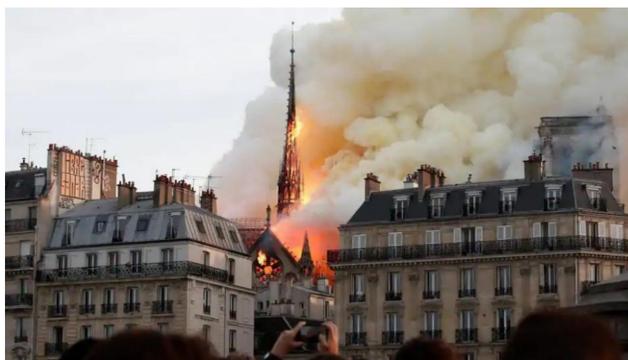
FIGURE 5 Notre Dame Cathedral fire in Paris  
(Katz & Weber 2020)

Figure 5 shows the fire at Paris' Notre-Dame Cathedral (Katz & Weber 2020). Although fire detection systems were in place, there were no suppression systems. The cathedral was under renovation at the time, and the fire started in the wooden roof. Steep stairs made firefighting difficult, especially on the upper floors. The wooden frame in the north tower, holding eight large bells, also caught fire. If the bells had fallen, the towers and the whole building might have collapsed. Over 400 firefighters responded, while another 100 formed a human chain with police and social workers to save valuable artifacts. Firefighters worked mainly inside the cathedral to avoid forcing flames inward, as external water posed that risk. Luckily, the stone-vaulted ceiling contained the fire, limiting interior damage. As of September 2020, the exact cause remained unknown, with possible sources including an electrical short circuit or a cigarette.
