## Comparative Study of Fibre Bragg Grating and Strain Gauges for Fatigue Crack Detection in Mild Steel

**Keywords:** Fibre Bragg Grating (FBG); strain gauge; mild steel; crack monitoring

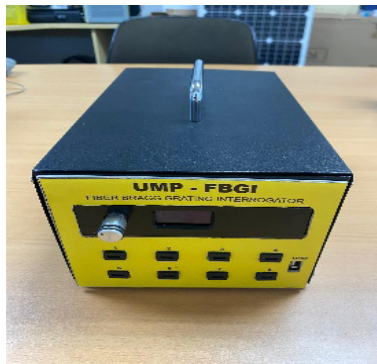
FIGURE 3. Fibre Bragg Grating Interrogator System

Figure 3 shows the FBG interrogation system connected to a laptop, allowing observation of wavelength shifts occurring during the test. This system is used to monitor signals from the FBG sensor in real time and display the wavelength shift readings through the software interface on the computer.

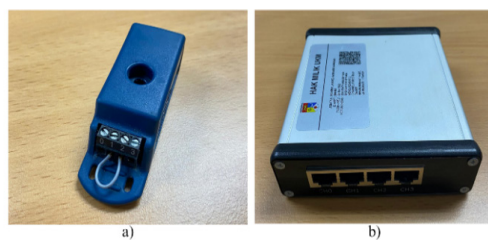
Strain data during the fatigue test was collected using a data acquisition device (DAQ), namely the National Instruments 9237 (NI-9237). This device functions to acquire signals from the strain gauge mounted on the surface of the mild steel plate specimen. The strain gauge was connected to the NI-9945 module, which is a quarter-bridge completion accessory, before being linked to the NI-9237 system. The entire setup was then connected directly to a laptop, enabling real-time data recording and display of strain values. Figure 4 illustrates the NI-9945 component connected to the strain gauge sensor and data acquisition system that will connect with NI-9945 and laptop.

FIGURE 4. a) NI-9945 module b) Data Acquisition (DAQ) system

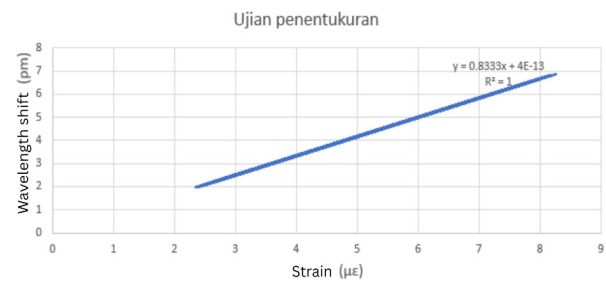
FIGURE 9. Strain test results for determining the sensitivity of the FBG sensor

The slope observed in Figure 9 indicates the sensitivity value of the FBG sensor, which was found to be  $0.8333 \text{ pm}/\mu\epsilon$ , with an  $R^2$ -value of 1. Based on this  $R^2$ -value, it can be concluded that the sensitivity obtained from the calibration test falls within a different parameter compared to the ideal FBG sensitivity of  $1.2 \text{ pm}/\mu\epsilon$  as stated by (Balarabe et al. 2018).
