# History of the 1963 Vaiont slide: the importance of geological factors

E. Semenza · M. Ghirotti

**Key words** Vaiont · Ancient landslide · Geology · Geomorphology

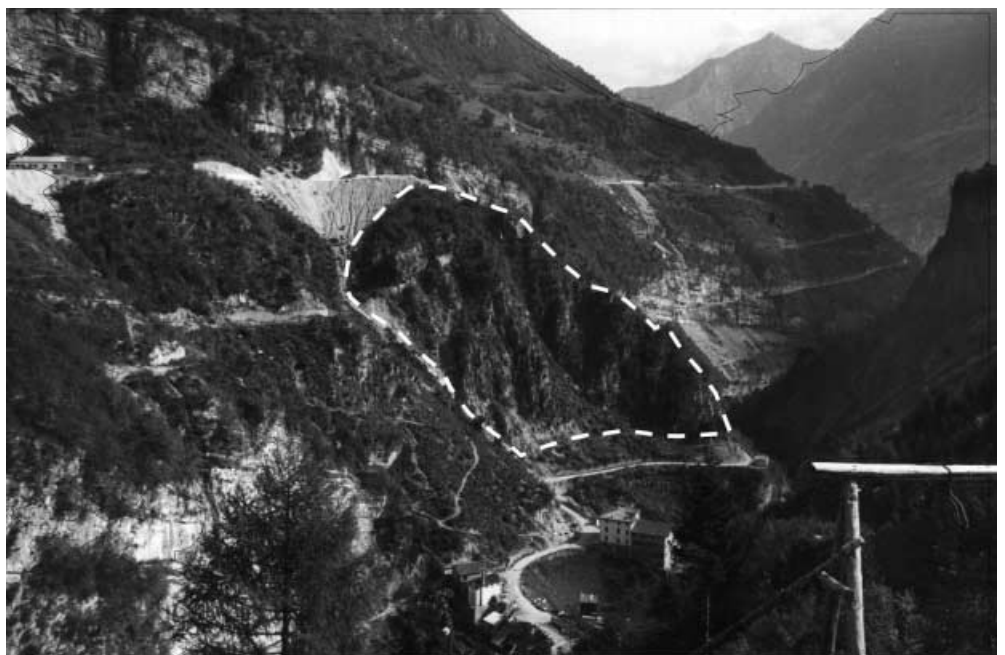
**Fig. 5**

Right slope of the Vaiont valley, seen from left abutment of dam. *Right* Northern face of Punta del Toc; *left* regular face of Cretaceous limestones folding towards east; *centre* Colle Isolato (outlined with *dashed line*)

2. The subsequent cutting of the Vaiont gorge had divided the large landslide mass into two unequal parts, the larger being on the left of the gorge. The landslide deposits, on the right of the gorge, were clearly distinguishable from the in-situ rock mass and have been named Colle Isolato by the authors (Figs. 5 and 6).

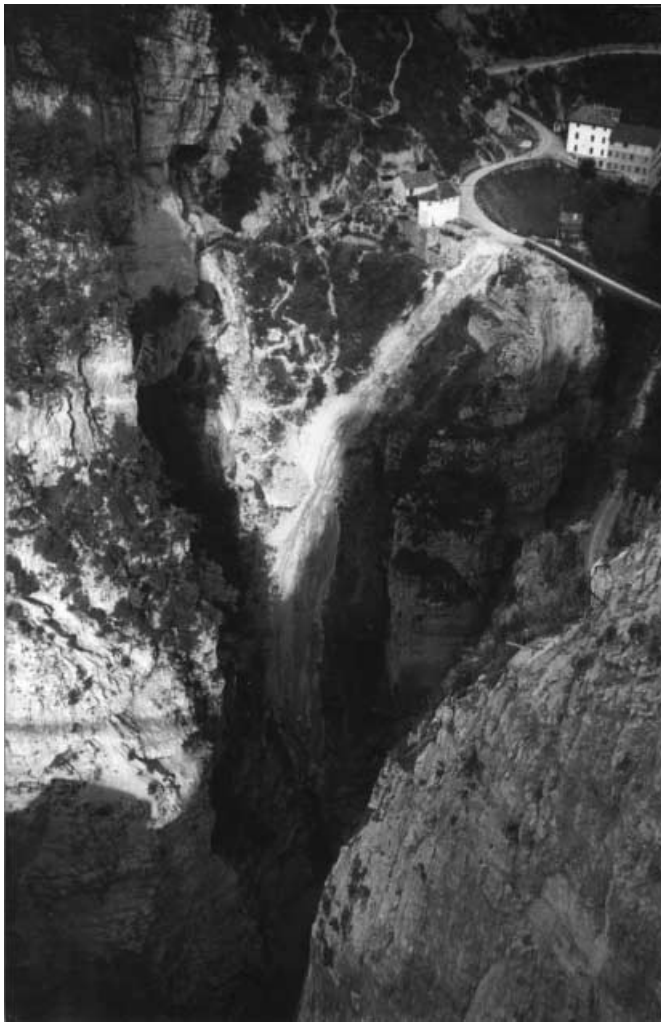
**Fig. 7**

View from left abutment of dam (Semenza, September 1959). *Right* Very narrow epigenetic gorge of the Vaiont at Ponte del Colomber; *left* church, below which morphological indications exist of the Vaiont paleochannel. In 1961, during excavation at mouth of bypass tunnel, horizontal layers of gravel were observed here at the level of road, similar to those at Colle Isolato (cf. Fig. 12). It is likely that here, as at analogous points further upstream (Figs. 5 and 6), a frontal portion of ancient landslide remained which was subsequently demolished by erosion

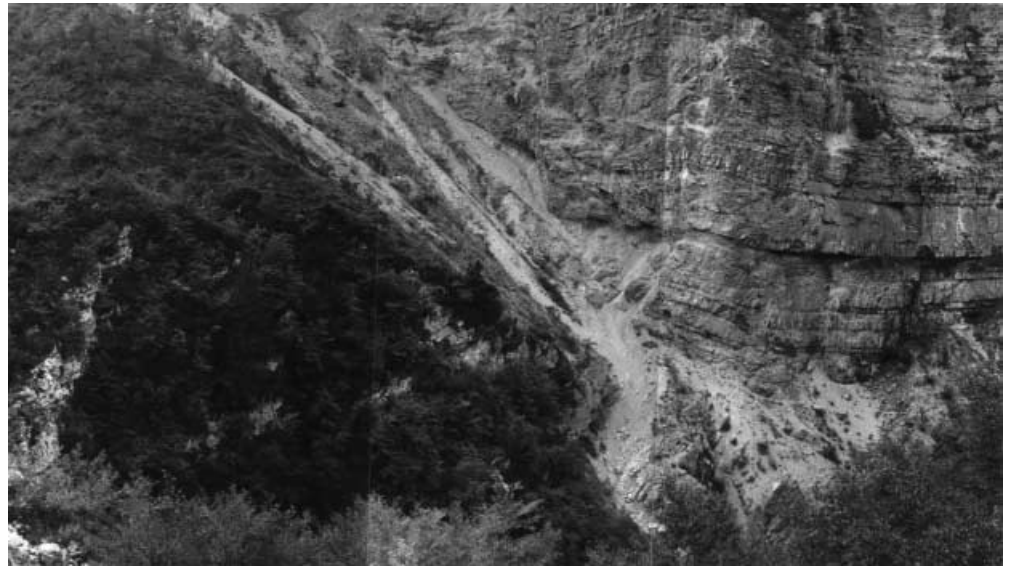
**Fig. 9**

Easternmost part of northern wall of old landslide (cf. Fig. 4, point b) showing slight fold, truncated by a band of mylonites and tectonic breccia and in-situ layers of Cretaceous limestone. The anomalous contact plane corresponds with the eastern flank of the ancient landslide. This is the only area where slide failure surface was clearly seen in 1959

major modification is to highlight the narrowness of the present gorge (Fig. 8). The eastern part of the old landslide can be seen in Fig. 9. Close to the gully is a slight fold which has been truncated by a movement zone where mylonites and tectonic breccias are now present.

5. The landslide mass was very fractured and folded in an east-west direction, as is clearly visible in the north-western wall of Pian del Toc (Fig. 4) and at its eastern edge (Fig. 9).

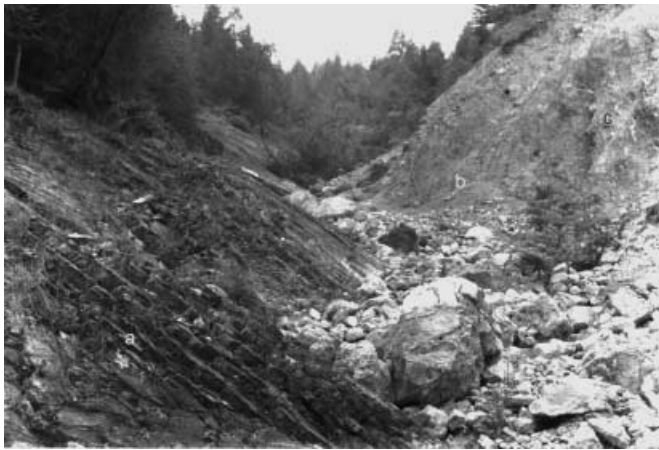
**Fig. 11**

Western branch of the Massalezza Stream at some 1000 m (1960). *a* Upper Jurassic layers dipping 40° to north; *b* mylonites and tectonic breccia; *c* very fractured Cretaceous limestones. This ancient failure surface was reactivated by the 1960 and 1963 movements

A new geological survey showed that in the two tributary streams that flowed into the Massalezza Stream from the east and the west at about 920 m asl, the transition from the bedrock (in the south; a in Fig. 11) to mylonites (b in Fig. 11) and a very fractured rock (in the north; c in Fig. 11) was clearly recognisable.

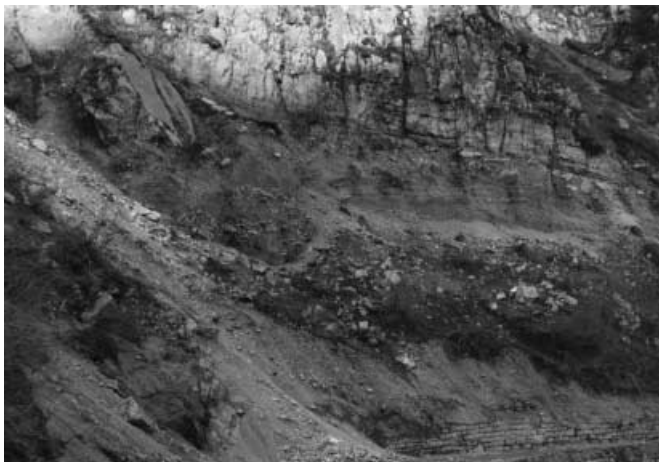
**Fig. 12**

Base of western slope of Colle Isolato when lake water had dropped to below 600 m asl

The lowering of the lake level to 600 m asl also made it possible to clearly observe the bottom of the Colle Isolato. The water had removed the vegetation and hence this portion of the old landslide mass, composed of fractured

rock resting on stratified alluvial gravels deposited by the old postglacial Vaiont River, could be clearly seen (Fig. 12).

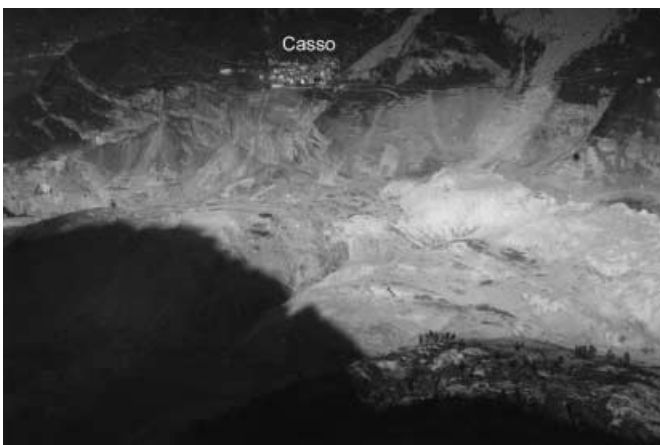
**Fig. 14**

From the helicopter (Semenza, 28 October 1963). Above is right slope of the Vaiont valley with the effect of the wave which reached 930 m asl at Casso and 950 m asl some 100 m to the west

nical fraternity and numerous researchers formulated hypotheses as to the causes of the landslide and in particular the reasons for the high velocity of the movement. It was the velocity that was the main cause of the height of the wave produced in the lake (Fig. 14) and therefore of the destruction that ensued.
