Occupational Risk Assessment: Review of Wooden Scaffold Board Application in Malaysian Oil and Gas Industry

MOHD JAMIL ABDUL WAHAB*, NOOR AZRIEDA ABD RASHID,
SALMIAH UJANG & LIM SENG CHOON

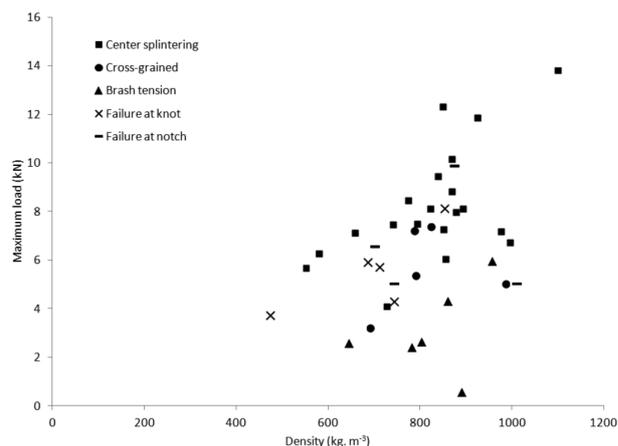
FIGURE 3. Facies of timber scaffold board failure (bottom view)

Overall, there were five modes of fracture observed during destructive test namely center splintering, cross-grained, brash tension, failure at knot and failure at notch. The facies of failure is described in Figure 3. Correlation between density, maximum load and failure mode of each board is shown in Figure 4. High density boards demonstrated higher maximum strength. Most boards of higher strength failed by center splintering. Apparently, majority of the lower strength boards failed in brash tension mode.

boards with notches, 4 boards failed at the edge cut during flexure test. The notching of timber board develops stress concentrations around the notch, as well as a reduction of the area resisting the bending and shear forces. Burawska et al. (2011) reported that the maximum stress in bending of notched solid timber depends on the size of the opening, the larger the opening, the higher the stress.
