Assessing Geohazard Risk on a Weathered Sedimentary Rock Slope Using Photogrammetry Approach

Keywords: Weathered sedimentary rock slope; unmanned aerial vehicle (UAV); photogrammetry; discontinuity characterisation; and geohazard vulnerability and risk analysis

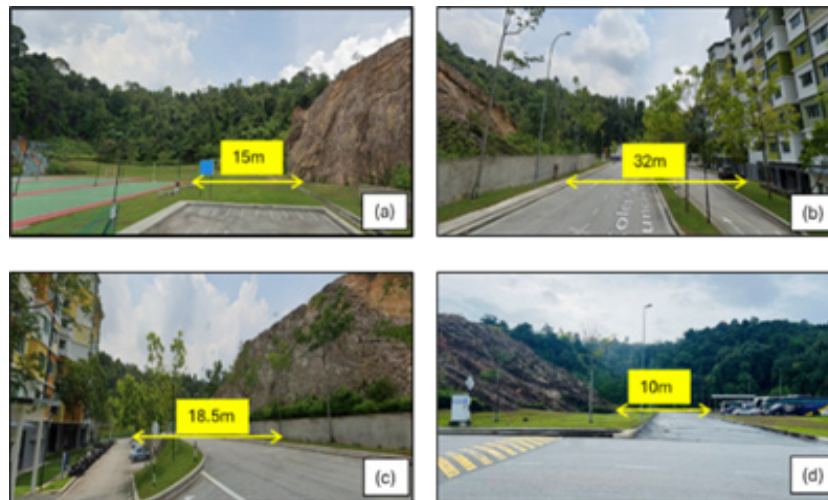
Near the rock slope, few infrastructures were constructed. As seen in Figure 2, four sport courts were located at Location A, two blocks of student hostels at Location B, while the bus depot was located at Location C. The distances were roughly 15 metres for the nearest sport court, 32 metres (Kolej Baiduri), 18.5 metres (Kolej Zamrud), and 10 metres for the bus depot from the toe of the rock slope.

FIGURE 2. Distance of infrastructures to the rock slope (a) Location A; Sport courts; (b) Location B; Kolej Baiduri; (c) Location B; Kolej Zamrud; (d) Location C: Bus depot

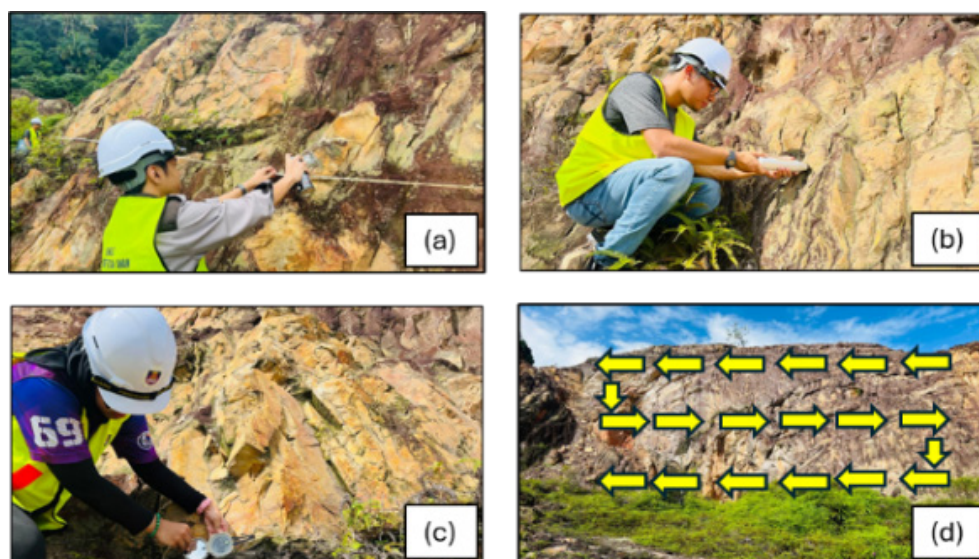
As shown in Figure 3, the discontinuity survey and the photogrammetry technique utilising an unmanned aerial vehicle (UAV) were both carried out on-site for data gathering. The activities involved in discontinuity surveys

were establishing a scanline, a surface strength test by using a Schmidt Rebound Hammer and measurement of dip angle and dip direction of the discontinuities by using a geological compass.

FIGURE 3. Discontinuities survey and photogrammetry method (a) Distance measurement; (b) Surface strength measurement; (c) Orientation of discontinuities measurement; (d) Flight path mode of drone

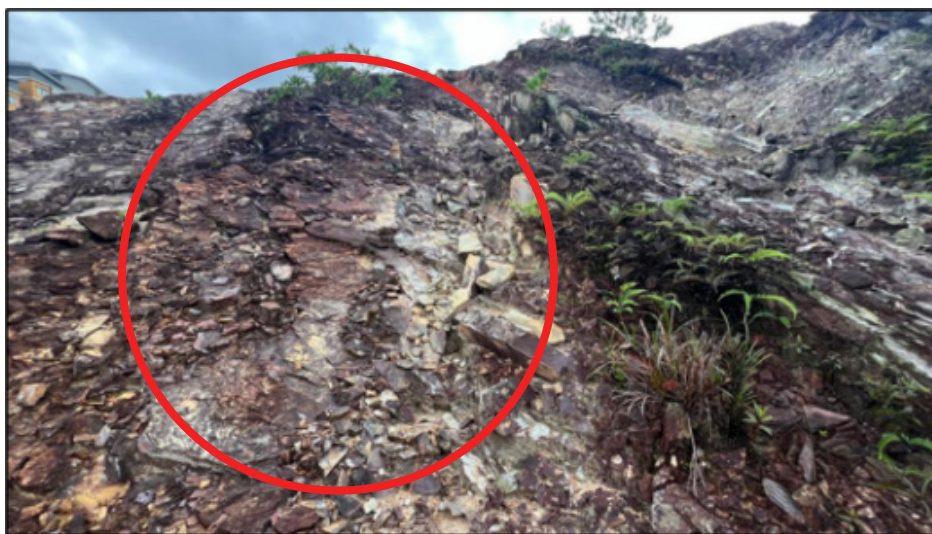
The moderately weathered sedimentary rock at position C is delicate and breakable with hands and a geological hammer, as seen in Figure 7. More than half of the rock material breaking down into soil is categorised as highly worn sedimentary rock. Advanced weathering decreased the rock's shear strength and made it more prone

to failure, especially in the weak shale layers. A light-coloured rock surface means that darker minerals have

leached or that oxide coatings or clay minerals have formed because of weathering.

FIGURE 7. Light-coloured rock surface shows the moderately weathered condition at Location C

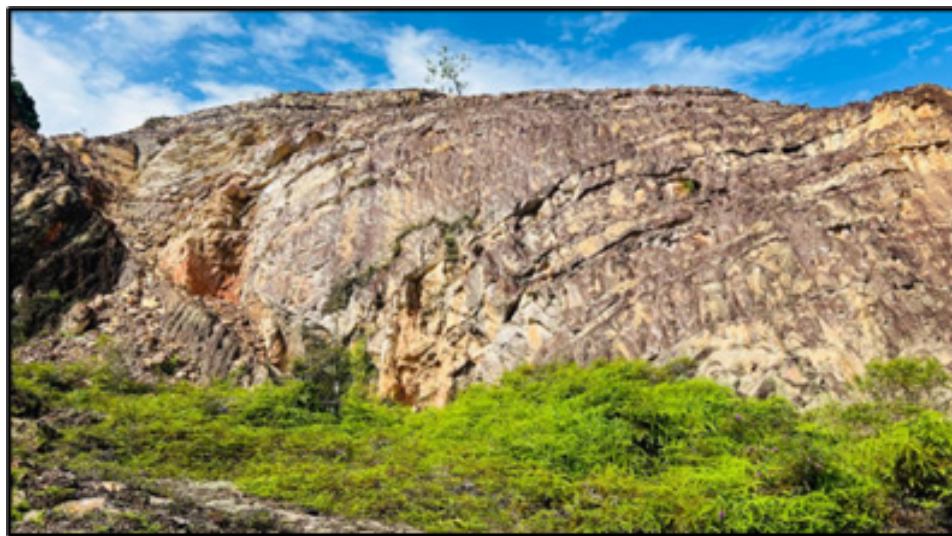
The Agisoft Metashape program was used to import photos taken from photogrammetry data. Figure 8 displays the UAV-captured image of the rock slope, and Figure 9 displays the high-resolution 3D model of site A. The

FIGURE 8. UAV-captured image by using drone

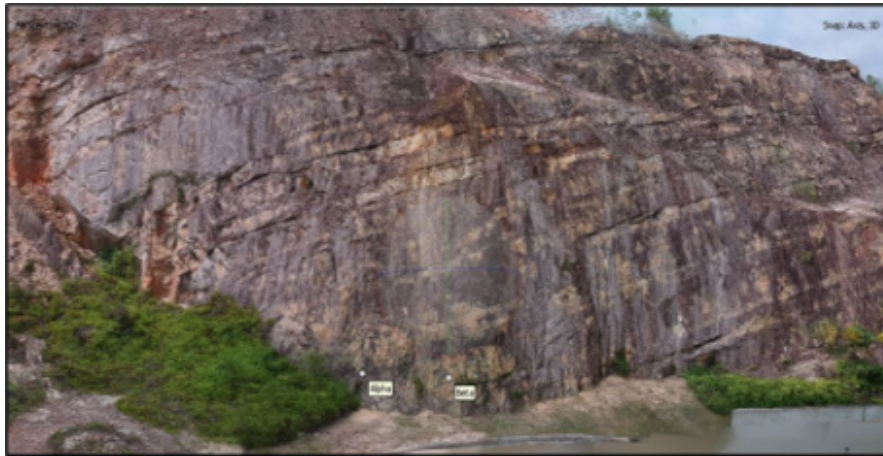
generated 3D model was aligned with the study by Nagendran et al. 2019; Wang et al. 2019; Ren and Meng 2022; Guo et al. 2023 despite the different 3D model programs that were utilized in each study. In addition, the ruler in the software was used to measure the slope geometry, including slope height and width.

FIGURE 9. A 3D model of Location A created with Agisoft Metashape software

Critical anisotropic planes, such as bedding planes, joint sets, and fault zones, were then found by kinematic analysis to be possible sliding surfaces. The 3D point cloud data produced by Agisoft Metashape was processed using CloudCompare software. All measurements of bedding planes, slope angles, and joint orientations are made by this software. Stereonet was also used to assess possible failure modes and locate important anisotropic planes. Plotting joint sets and bedding planes on stereographic projections was done by integrating data from CloudCompare. Planar failure is predicted to happen along steeply sloping bedding planes parallel to the slope face at locations B and C, according to the kinematic analysis. On the other hand, where the plunge direction coincides with the slope at Location A, wedge failure could occur at the junctions of joint sets and bedding planes.

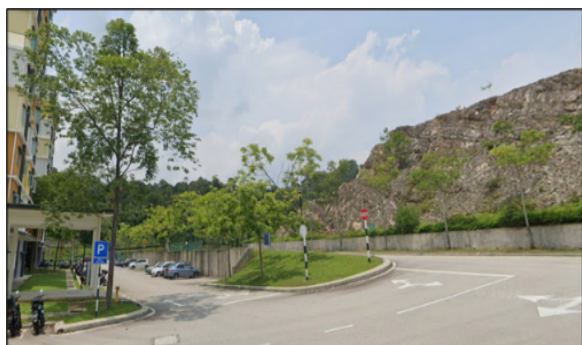
Additionally, two retaining walls with horizontal drains were built at the toe of the slope, as illustrated in Figure 11. As the kinematic analysis projects the possible planar failure in this location, the retaining walls were functioning to resist the lateral stresses exerted by the rock mass and manage groundwater levels, supporting the findings by Du et al. (2023) and Bakhshayesh et al. (2023).

FIGURE 11. Double retaining walls with horizontal drains at Location B
